## RCRA INSPECTION REPORT

Facility Name: File: G-02-02-004  
Jard Company Incorporated  
Bowen Road  
Bennington, VT 05201  
(802) 442-3173

Type of Operation: Capacitor Manufacturer

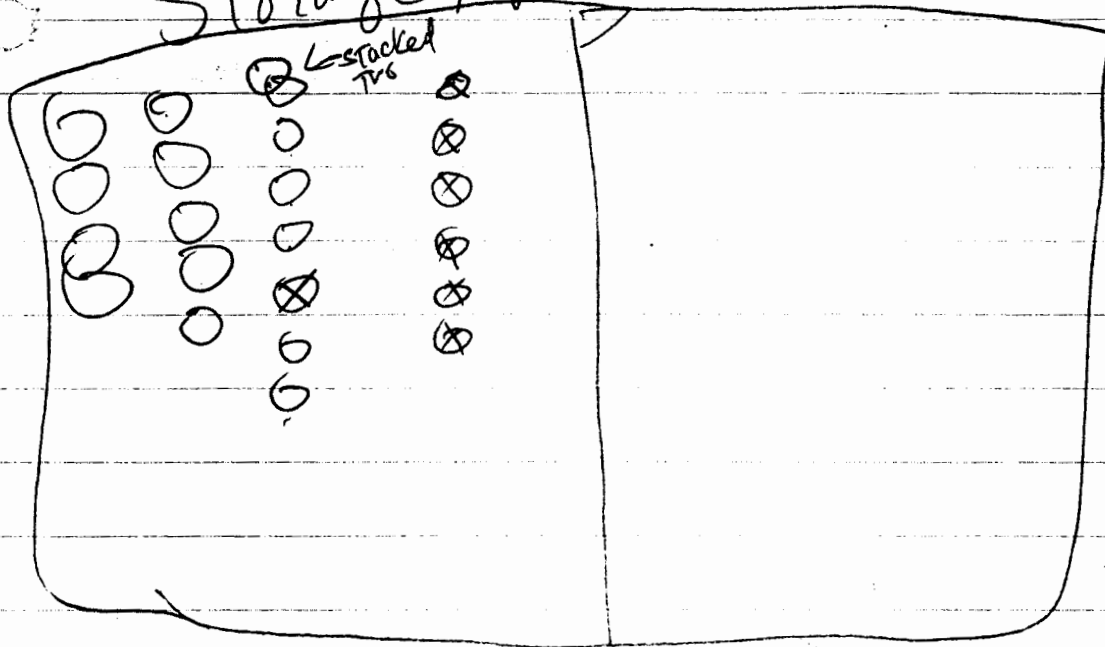
## Storage Diagram

Further down along this side of the building was a fenced in storage area. The area was locked and a "windshield" survey of the enclosure revealed hazardous waste drums in storage. There were 7 fiber drums containing wastes, 15 fifty-five gallon drums and 1 ~thirty gallon drum (marked corrosive). The front side of the enclosure had ~35 fifty-five gallon drums and ~30-40 assorted sized containers up to ten gallons in volume. Containers could be seen with masking tape or other writing indicating the material was dirty or contaminated. The various hazardous materials seen included oil, methyl alcohol, toluene, trichloroethylene, hydrochloric acid, asbestos roof coating, paint enamel, methanol, acetone and plastic remover.

7 Fiber drums <  
 15 55 gallon  
 1 ~30 gallon corrosive label

oil

methyl alcohol

Falrene

trichloroethylene

Hydrochloric Acid

13 Books, w/ of coating

Paint Enamel

Methanol

Pectone

Plastic scum

~ 35 55 gallon steel  
 ~ 30-40 5, 10 gal assorted other size
